# Operating Experience Summary

## Office of Nuclear and Facility Safety

Summary 2000-09

# **Operating Experience Summary 2000-09**

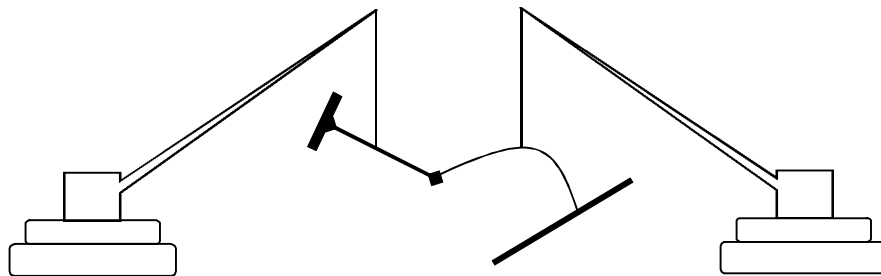
**Figure 9-1.**

Investigators determined that the water lance was lifted horizontally about 20 feet in the air, the crane holding the hose connection end (the top) elevated to move the lance toward the vertical, and the lance broke at the upper coupling. The two sections of the lance, still attached to the crane rigging, swung free with the end of the lower 40-foot section hitting the ground and bouncing at least twice (Figure 9-1.).

Investigators learned that the couplings on the lance were only hand tight. This resulted in loose thread engagement, reducing the shear strength capacity of the threads. A field inspection of the failed threads indicated that the threads resisted a moment at the coupling joint. The pattern of failure at the threaded end of the pipe indicated that the crane supporting the hose end of the lance caused a bending moment at the first joint that may have exceeded the ultimate strength of the material. The lance severely deformed plastically at the first joint. Water inside the lance shifted by gravity to the nozzle end, adding a bending moment at the deformed joint, resulting in additional plastic deformation and the failure. The direct cause of the pipe/coupling connection failure, as determined by engineering analysis, was inadequate design of the lance that resulted in excessive stress applied to the threaded connections during the lift. Investigators determined that there was a lack of clearly defined procedures governing the fabrication and use of fabricated tools like the water lance. No engineering evaluation was performed to determine if the construction of the lance was suitable for its intended purpose and the stresses applied during deployment.
